Thermal Imaging Report

Xxxx St, XXXxtown

Report Number: Xxxx
Prepared for: Xxxx Xxxx
Date: Xxxx

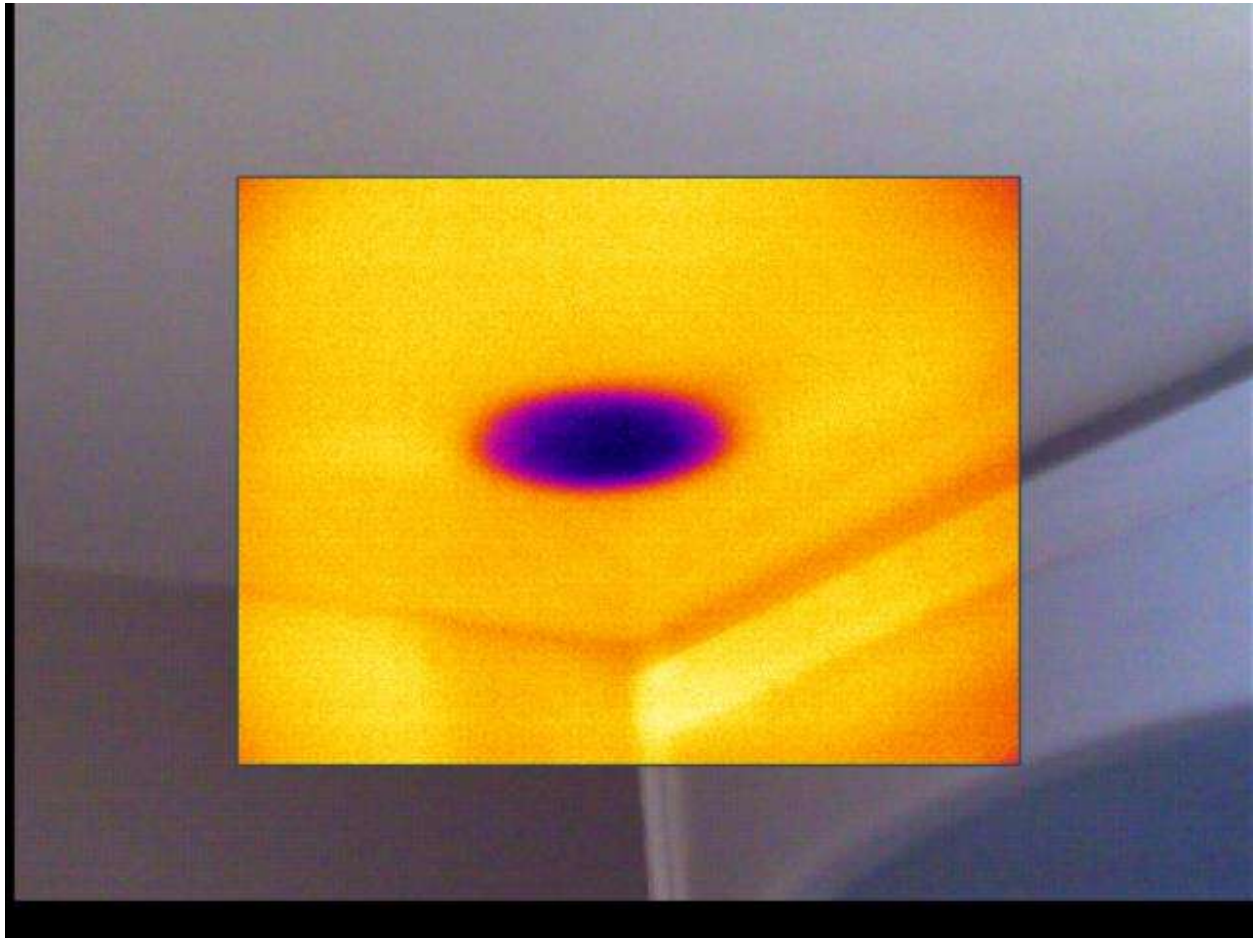
Item Number	1
Floor	1
Room	Lower level bathroom
Facing Direction	Up
Other Details	Second level bathroom is above this area
Anomaly Description	Colder area
Analysis	Appears to be directly below second floor toilet; no visible water stains however elevated moisture readings confirmed by moisture meter. Suspect toilet is leaking. Concealed damage is possible.
Recommendation	Licensed plumbing contractor to lift toilet and replace seal or other repairs as necessary.

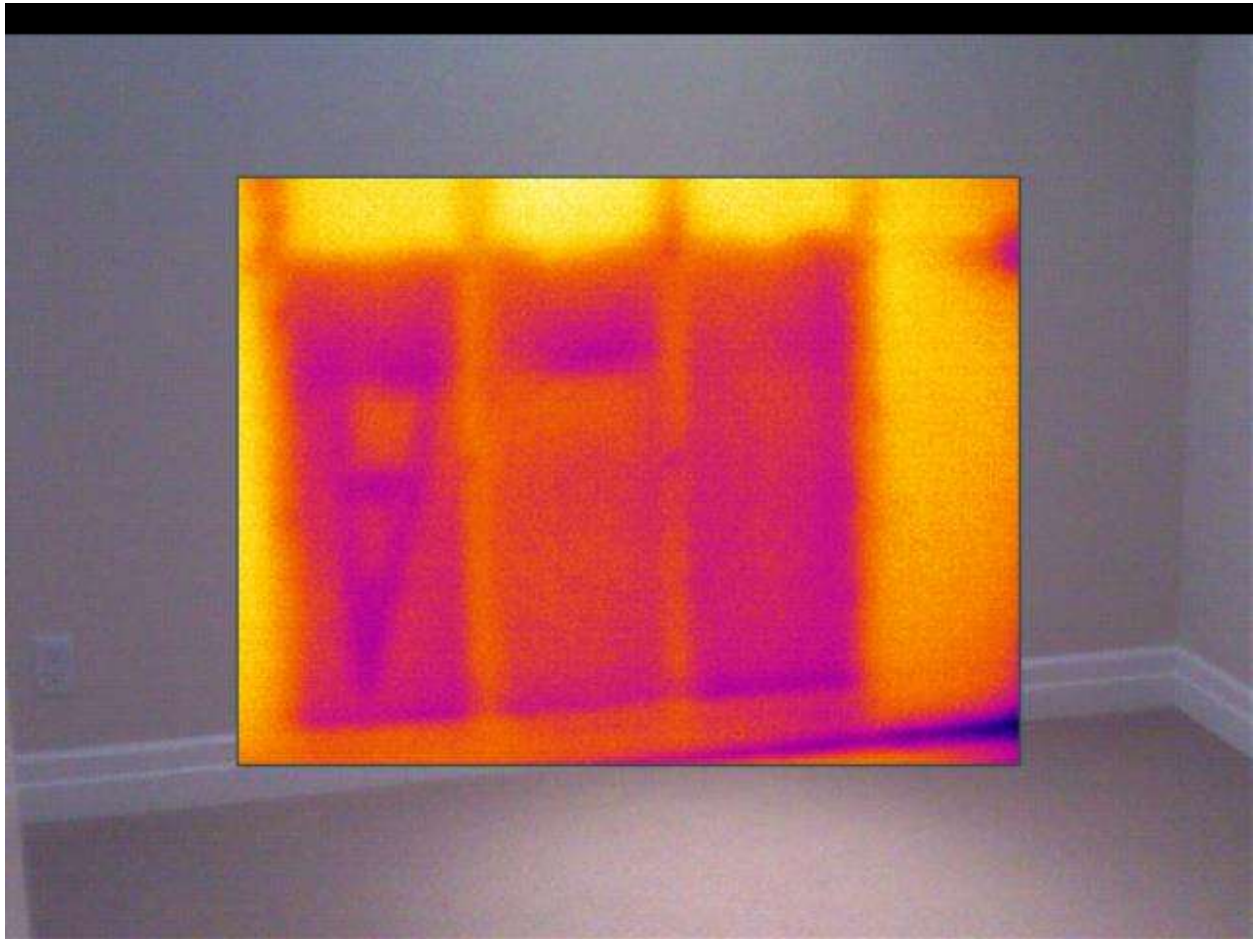
Item Number	2
Floor	Basement
Room	Front right room (office)
Facing Direction	Right side – below window
Other Details	
Anomaly Description	Colder areas between 3 studs
Analysis	Insulation is either missing or reduced in the bottom 3 feet of these 3 stud cavities.
Recommendation	Drywall finishes could be opened and insulation upgraded, however doing nothing is a viable option unless a comfort issue is noted in this room.

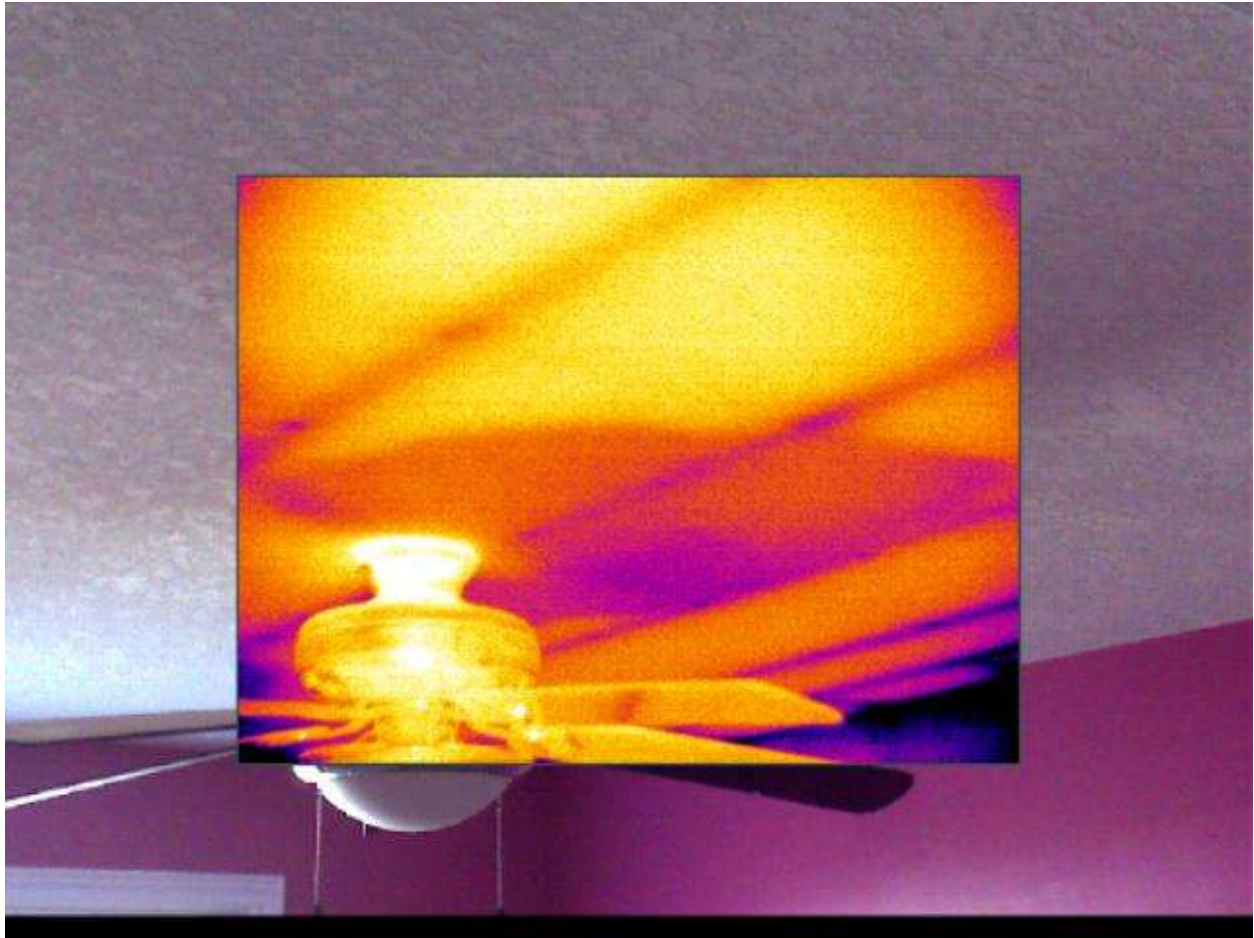
Item Number	3
Floor	2
Room	Rear bedroom
Facing Direction	Up
Other Details	
Anomaly Description	Colder area
Analysis	Roof leak is suspected – the insulation in the attic was subsequently examined and there is a large damp area that corresponds to thermal image pattern. Water has not seeped through any seams or drywall nails yet to cause any visible staining. Suspect roof vents are leaking under certain wind/rain conditions.
Recommendation	Roofing contractor to review roof, especially ridge and roof vent and make repairs.

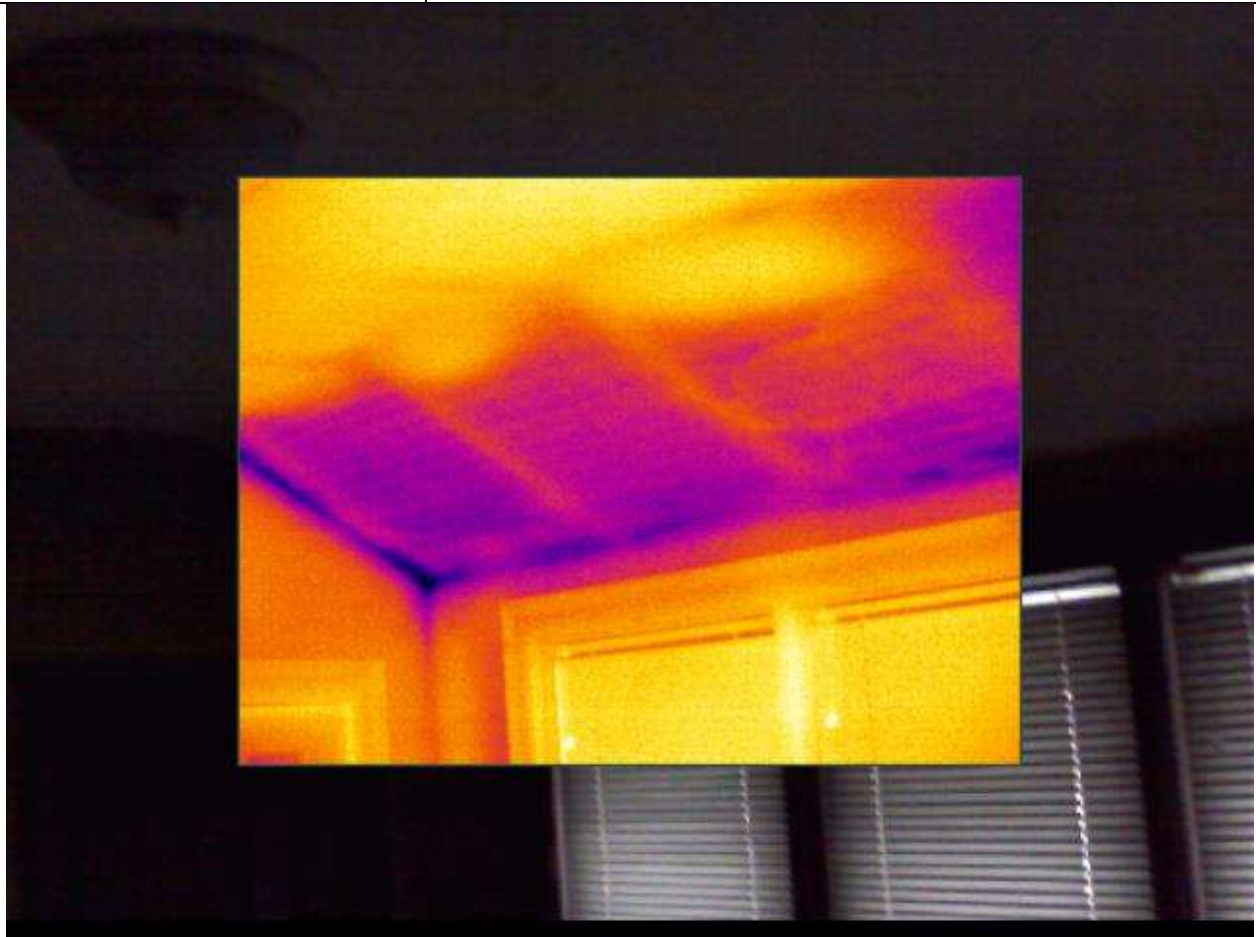
Item Number	4
Floor	2
Room	Front bedroom
Facing Direction	Front/up
Other Details	
Anomaly Description	Colder areas in cathedral ceiling space
Analysis	Lath and plaster visible in image; appears that attic insulation has partially fallen into cathedral cavities, however insulation in cathedral space is largely missing or a very low level.
Recommendation	Contact insulation contractor to discuss options. Cavities could be filled however roof space ventilation should also be considered.

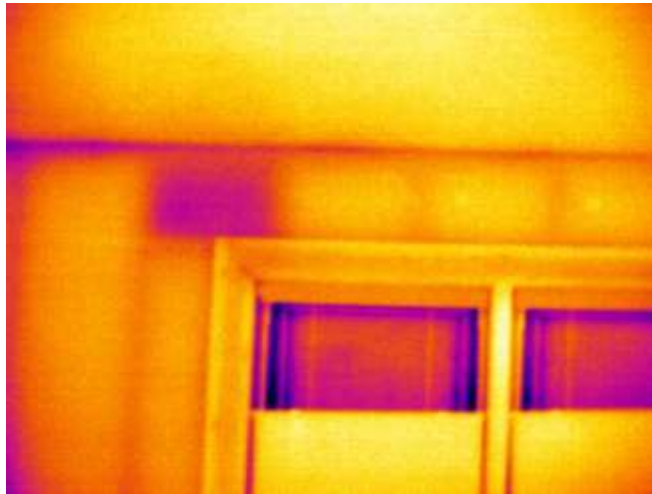
1)

Item Number	5
Floor	1
Room	Living room and dining room
Facing Direction	Front and back walls, respectively
Other Details	
Anomaly Description	Colder areas noted
Analysis	Exterior walls on main floor and second floor appear to have been insulated (retrofitted) with blown in cellulose fiber (insulation visible in wall openings at several outlets and light switches, and repaired plug holes noted in kitchen cabinets and several closets). Overall most cavities appear to have been well filled – the two spots shown below were missed: 1 – small area above living room window, 2 – area above rear sliding door.
Recommendation	Insulation contractor can be consulted to address these 2 missing areas.
